PROYECTO FINAL DE CARRERA

Patología estructural y del casco:

Métodos de protección, inspección, mantenimiento y reparación

Ingeniería Naval y Oceánica
Junio, 2014

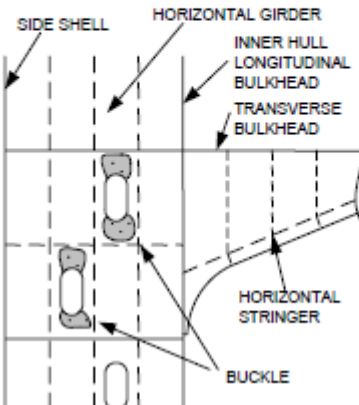
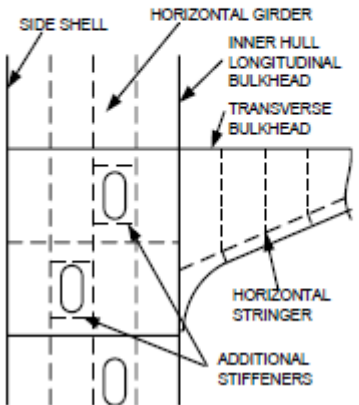
OIL Tankers		Guidelines for Surveys, Assessment and Repair of Hull Structure
Group 2	Cargo area	Example No.
	Wing ballast tank	6
Detail of damage	Panels of side horizontal girders in way of transverse bulkhead	
Sketch of damage		Sketch of repair

Factors which may have caused damage 1. High shear or compressive stress in the stringer. 2. Insufficient buckling strength.		Notes on repairs See Sketch.

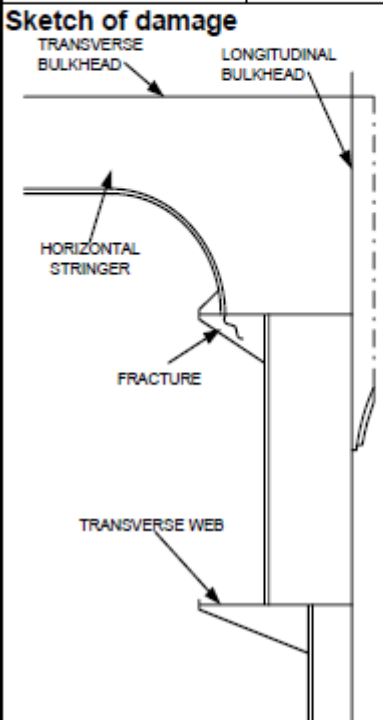
OIL Tankers		Guidelines for Surveys, Assessment and Repair of Hull Structure
Group 2	Cargo area	Example No.
	Wing ballast tank	7
Detail of damage	Fracture at connection of horizontal stringers to transverse web frames and horizontal girders	
Sketch of damage

Factors which may have caused damage 1. Stress concentration due to discontinuous structure. 2. High shear stress in the horizontal stringer.		Notes on repairs See Sketch.

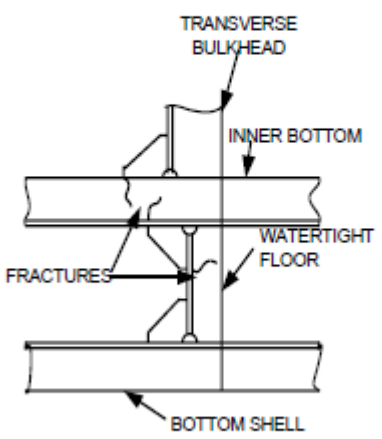
OIL Tankers		Guidelines for Surveys, Assessment and Repair of Hull Structure
Group 3	Cargo area	Example No.
	Bottom ballast tank	1
Detail of damage	Cracks in way of longitudinals connected to watertight floors	
Sketch of damage	<div style="display: flex; justify-content: space-around;"> <div style="text-align: center;">

<p>TRANSVERSE BULKHEAD</p> <p>INNER BOTTOM</p> <p>WATERTIGHT FLOOR</p> <p>FRACTURES</p> <p>BOTTOM SHELL</p> </div> <div style="text-align: center;">

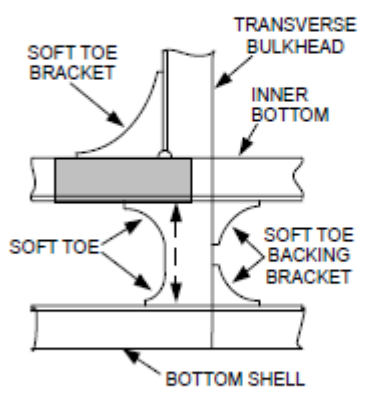
<p>SOFT TOE BRACKET</p> <p>TRANSVERSE BULKHEAD</p> <p>INNER BOTTOM</p> <p>SOFT TOE</p> <p>SOFT TOE BACKING BRACKET</p> <p>BOTTOM SHELL</p> </div> </div>	
Factors which may have caused damage	<p>1. Asymmetrical connection of bracket in association with a backing bracket, which is too small.</p> <p>2. Relative deflection between adjacent floor and transverse bulkhead.</p> <p>3. Inadequate shape of the brackets.</p> <p>4. High stresses in the inner bottom longitudinal and the floor stiffener.</p>

Notes on repairs	See Sketch.

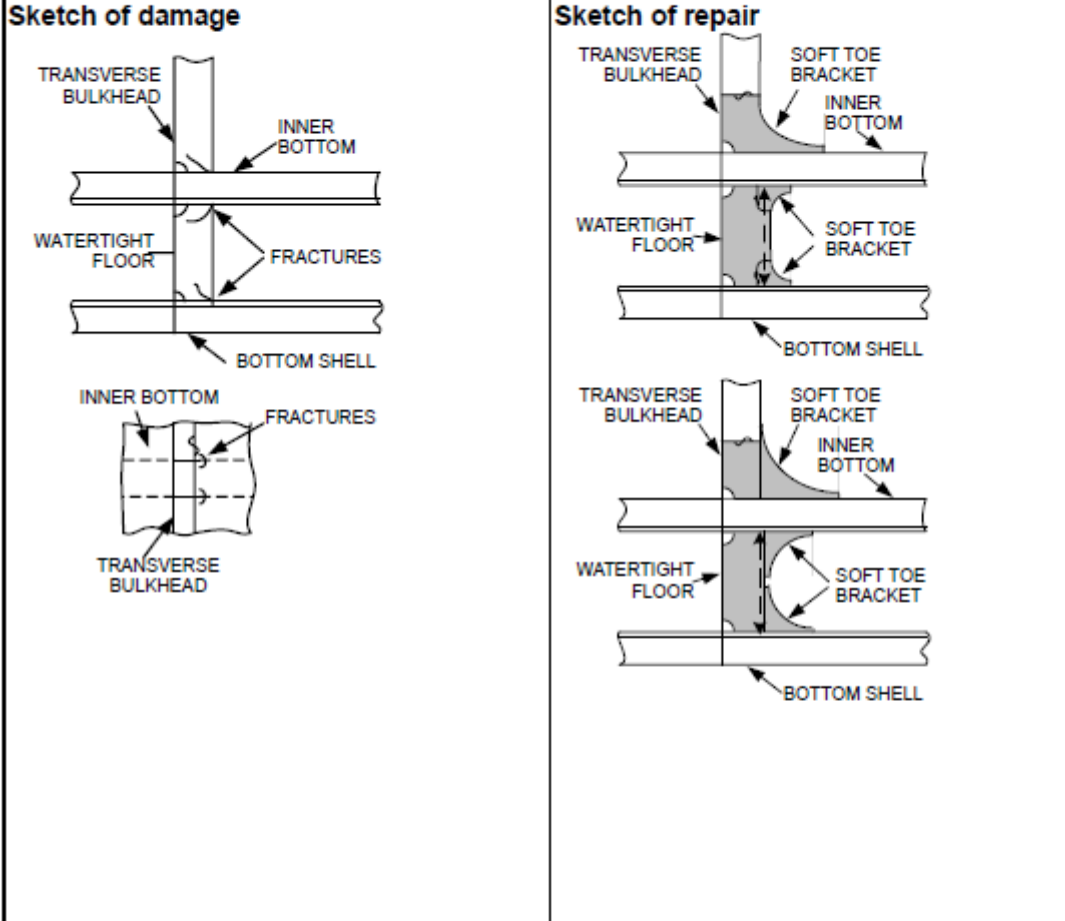
OIL Tankers		Guidelines for Surveys, Assessment and Repair of Hull Structure
Group 3	Cargo area	Example No.
	Bottom ballast tank	2
Detail of damage	Fracture in way of stiffeners at connection of inner bottom and bottom shell to transverse bulkhead and floors.	
Sketch of damage

Factors which may have caused damage	Notes on repairs See Sketch. 1. If tank top plating is fractured, part crop and insert. 2. Proper alignment between bulkhead stiffener and inner bottom longitudinal is critical for successful repair. 3. Soft backing brackets may also be added.

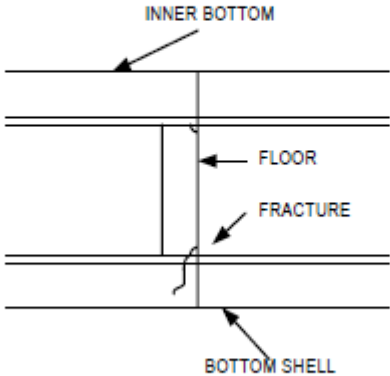
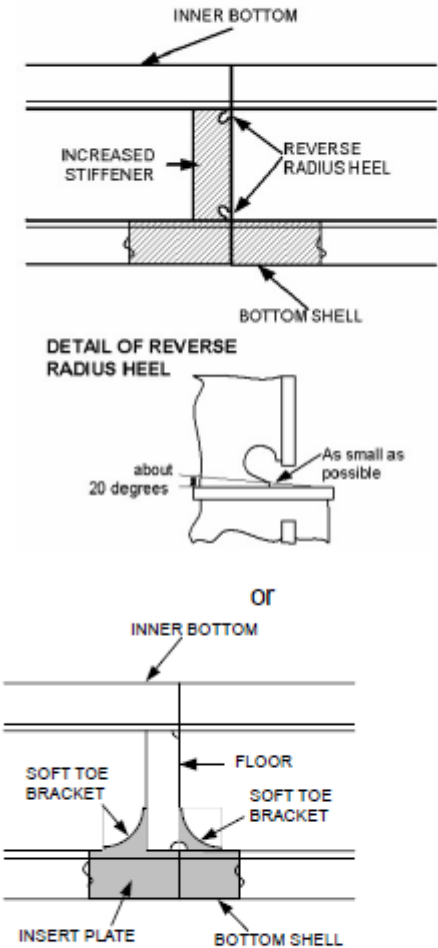
OIL Tankers		Guidelines for Surveys, Assessment and Repair of Hull Structure
Group 3	Cargo area	Example No.
	Bottom ballast tank	3
Detail of damage		Connection of longitudinals to ordinary floors.
Sketch of damage		Sketch of repair

Factors which may have caused damage 1. Asymmetrical connection. 2. Relative deflection of adjacent floor to transverse bulkhead.		Notes on repairs See Sketch.

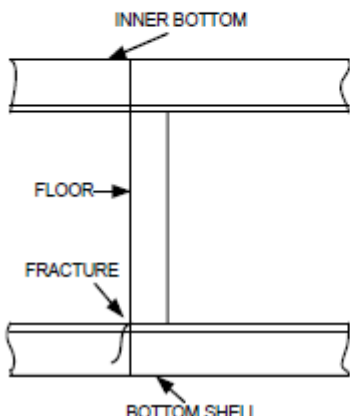
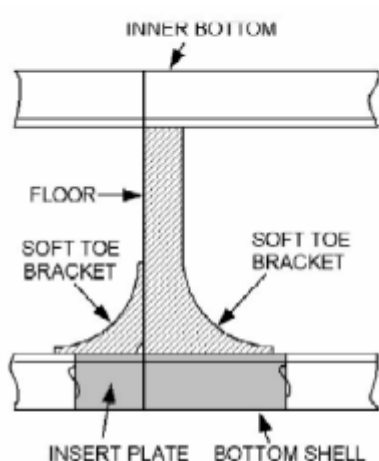
OIL Tankers		Guidelines for Surveys, Assessment and Repair of Hull Structure	
Group 3	Cargo area	Example No.	
	Bottom ballast tank	4	
Detail of damage	Connection of longitudinals to ordinary floors		
Sketch of damage		Sketch of repair

Factors which may have caused damage		Notes on repairs	
1. Stress concentration at the connection of bottom longitudinal and stiffener on floor.		See Sketch. 1. Butt welds in bottom longitudinal should be kept clear of the soft toe bracket toes. 2. If possible soft toe bracket and vertical stiffener should be integral.

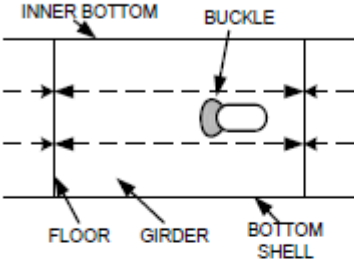
OIL Tankers		Guidelines for Surveys, Assessment and Repair of Hull Structure
Group 3	Cargo area	Example No.
	Bottom ballast tank	5
Detail of damage	Panels of bottom girders in way of openings.	
Sketch of damage

Factors which may have caused damage <ol style="list-style-type: none"> 1. High shear or compressive stress in the side girder. 2. Insufficient buckling strength. 		Notes on repairs See Sketch.

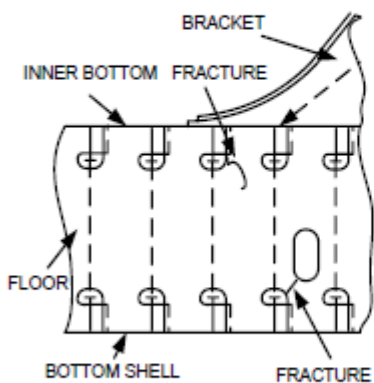
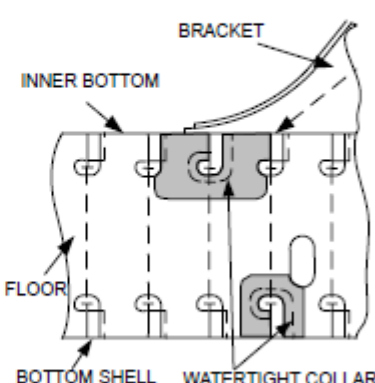
OIL Tankers		Guidelines for Surveys, Assessment and Repair of Hull Structure
Group 3	Cargo area	Example No.
	Bottom ballast tank	6
Detail of damage	Cut-outs on floors	
Sketch of damage		Sketch of repair

<p>Above for relatively small fractures.</p>

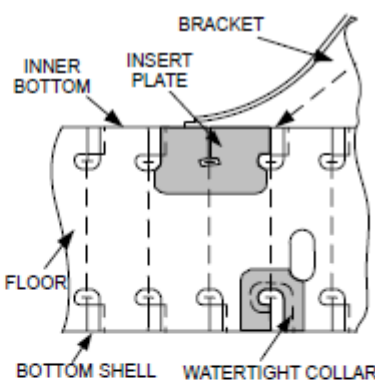
<p>Above method for larger fractures.</p>
Factors which may have caused damage <ol style="list-style-type: none"> 1. High stress in the vicinity of the transverse web frame bracket toe. 2. Lack of material between manhole and cut-out for bottom longitudinals. 		Notes on repairs <ol style="list-style-type: none"> 1. Top sketch: Gouge and reweld fractures then fit WT collars. 2. Bottom sketch: As an alternative to rewelding and fitting collar, crop and insert.

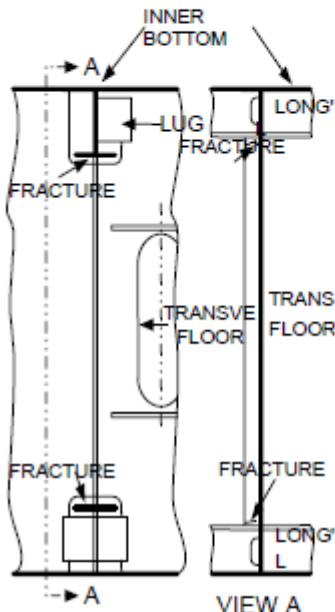
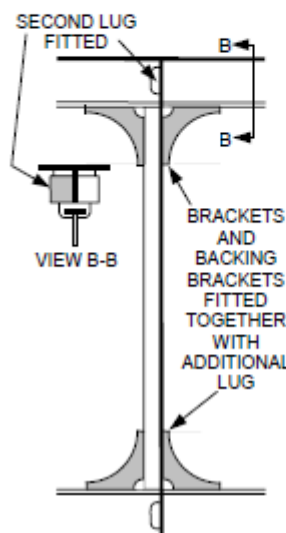
OIL Tankers		Guidelines for Surveys, Assessment and Repair of Hull Structure
Group 3	Cargo area	Example No. 7
	Bottom ballast tank	
Detail of damage	Fractured stiffener connection to bottom and inner bottom longitudinals.	
Sketch of damage		Sketch of repair

<p>VIEW A</p>

<p>VIEW B-B</p>
Factors which may have caused damage		Notes on repairs
<ol style="list-style-type: none">1. Asymmetric connection leading to high local stresses at the connection of vertical stiffeners of the transverse floors to the inner and outer bottom longitudinals.2. Wide slot for longitudinal leads to inefficient lug connection.3. Sharp corners or flame-cut edges producing a notch effect.4. Incomplete/defective weld at stiffener connection to the longitudinals.5. Dynamic sea way loads/ship motions.		See Sketch.

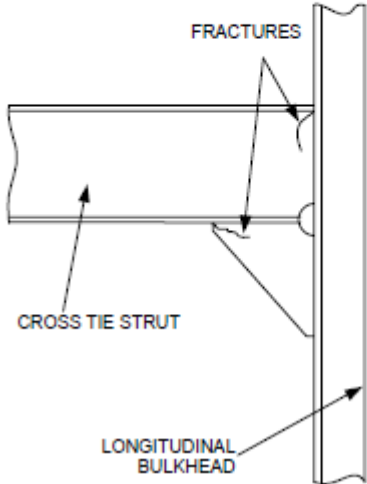
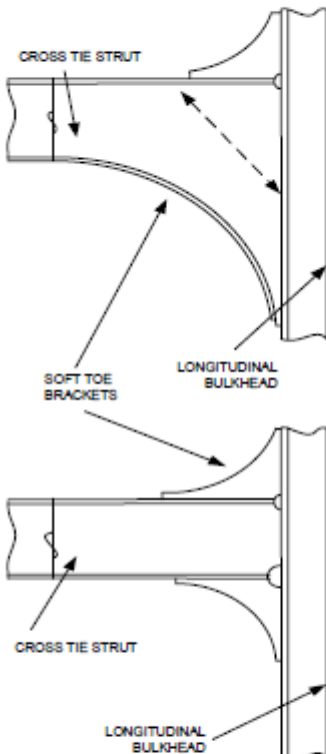
OIL Tankers		Guidelines for Surveys, Assessment and Repair of Hull Structure
Group 4	Cargo area	Example No.
	Web Frame in cargo tank	2
Detail of damage	Cross ties and their end connections	
Sketch of damage		Sketch of repair

Factors which may have caused damage <ol style="list-style-type: none"> 1. Stress concentration due to unsuitable bracket shape at juncture of cross tie to longitudinal. 2. Inadequate panel stiffening of web plate of cross-tie. 		Notes on repairs See Sketch.

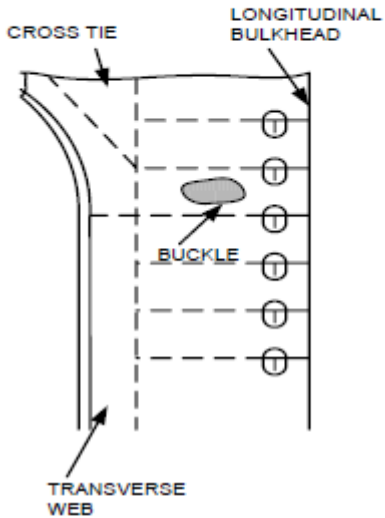
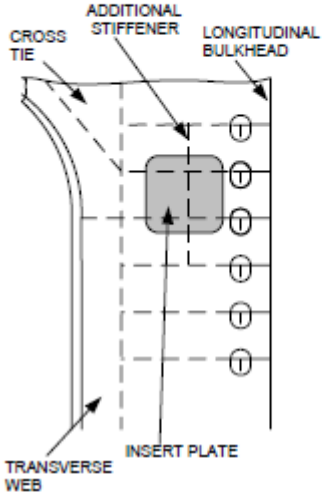
OIL Tankers		Guidelines for Surveys, Assessment and Repair of Hull Structure
Group 4	Cargo area	Example No.
	Web Frame in cargo tank	3
Detail of damage		Buckled transverse web plates in way of cross tie.
Sketch of damage		Sketch of repair

Factors which may have caused damage 1. Insufficient panel stiffening on transverse web.		Notes on repairs See Sketch. 1. Depending upon size of deformation, additional stiffeners may be sufficient.

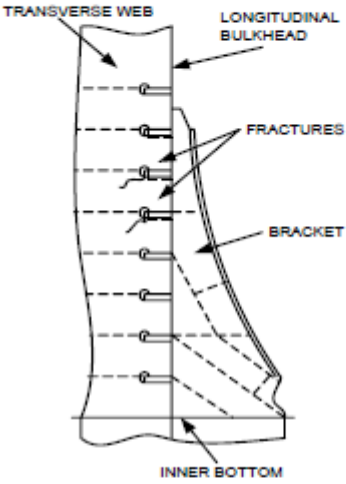
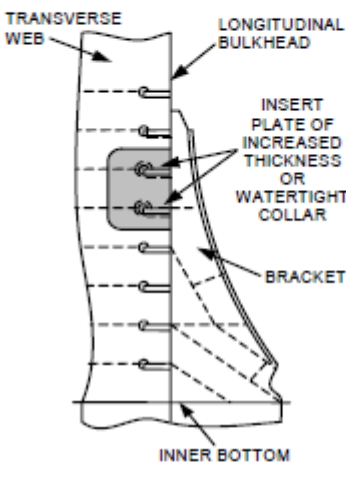
OIL Tankers		Guidelines for Surveys, Assessment and Repair of Hull Structure
Group 4	Cargo area	Example No.
	Web Frame in cargo tank	4
Detail of damage	Cut-outs around transverse bracket end.	
Sketch of damage

Sketch of repair

Factors which may have caused damage 1. High stresses at toe of bottom transverse end bracket. 2. Sharp corner at cut-out.		Notes on repairs See Sketch.

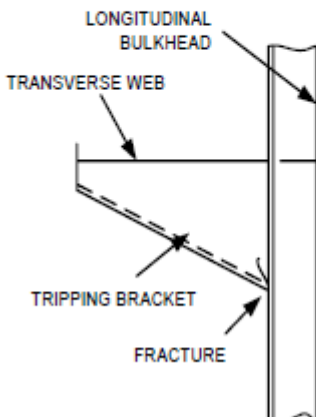
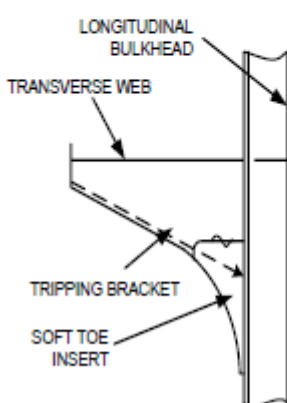
OIL Tankers		Guidelines for Surveys, Assessment and Repair of Hull Structure	
Group 4	Cargo area	Example No.	
	Web Frame in cargo tank	5	
Detail of damage	Fracture in way of connection of transverse web tripping brackets to longitudinal		
Sketch of damage		Sketch of repair

Factors which may have caused damage		Notes on repairs	
1. Hard spot at the toe of bracket. 2. Vibration.		See Sketch. 1. Soft bracket may be added on upper side of web, to avoid fracture at the heel.

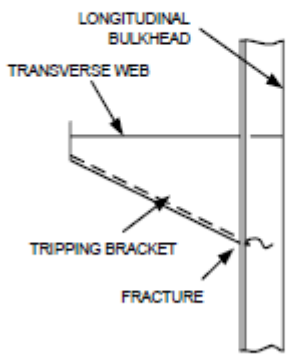
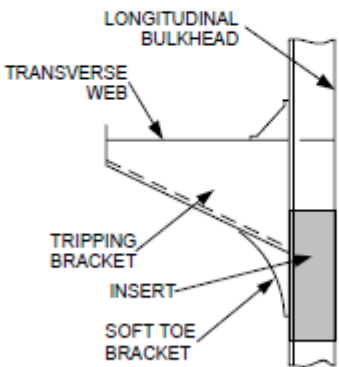
OIL Tankers		Guidelines for Surveys, Assessment and Repair of Hull Structure
Group 4	Cargo area	Example No.
	Web Frame in cargo tank	6
Detail of damage	Tripping brackets modification of the bracket toe.	
Sketch of damage

Sketch of repair

Factors which may have caused damage <ol style="list-style-type: none"> 1. Stress concentrations at toe of bracket. 2. High stress in longitudinal. 		Notes on repairs <p>See Sketch.</p> <ol style="list-style-type: none"> 1. Soft bracket may be added on upper side of web, to avoid fracture at the heel.

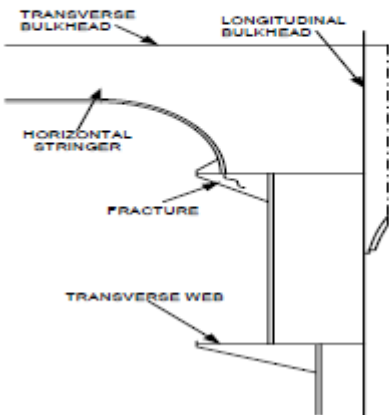
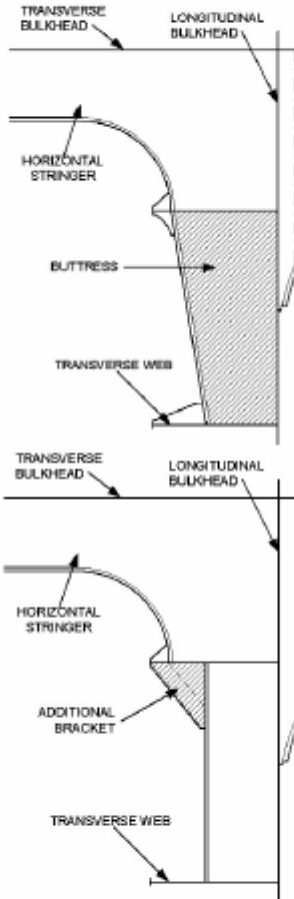
</div> </div>	
Factors which may have caused damage	<p>1. Stress concentration due to discontinuous structure.</p> <p>2. High shear stress in the horizontal stringer.</p>	
Notes on repairs	See Sketch.

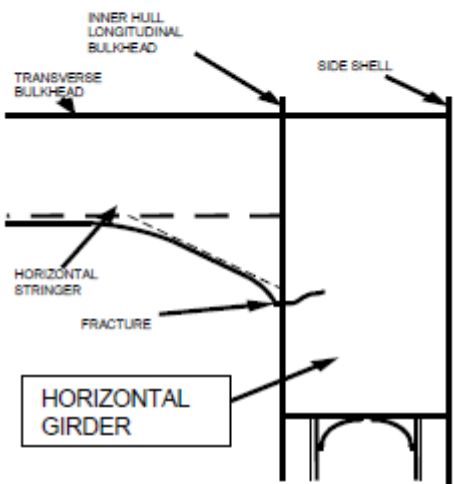
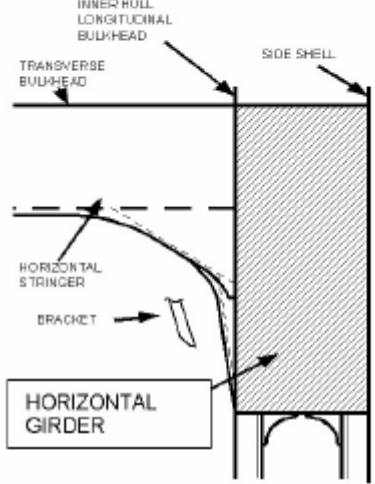
OIL Tankers		Guidelines for Surveys, Assessment and Repair of Hull Structure
Group 5	Cargo area	Example No.
	Transverse Bulkhead in cargo tank	2
Detail of damage	Horizontal stringer in way of longitudinal BHD cracked	
Sketch of damage		Sketch of repair

Factors which may have caused damage 1. Misalignment between bracket end and side girder in wing tank.		Notes on repairs See Sketch.

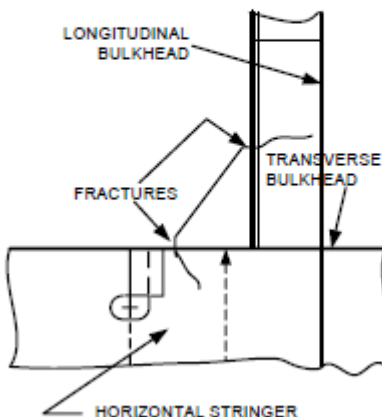
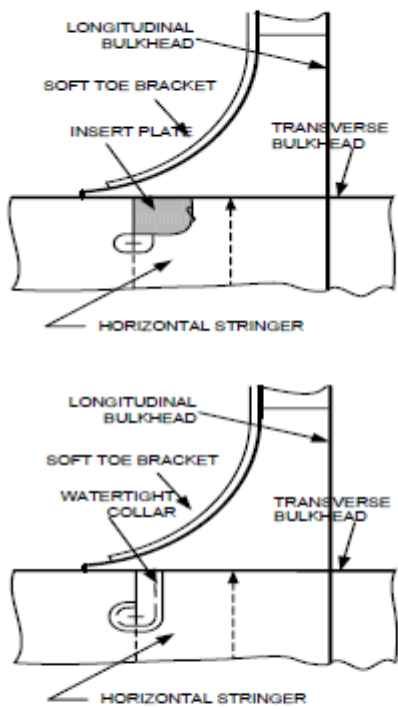
OIL Tankers		Guidelines for Surveys, Assessment and Repair of Hull Structure	
Group 5	Cargo area	Example No.	
	Transverse Bulkhead in cargo tank	3	
Detail of damage		Connection of longitudinals to horizontal stringers.	
Sketch of damage		Sketch of repair

Factors which may have caused damage		Notes on repairs	
<ol style="list-style-type: none">1. Stress concentration due to inadequate shape of the bracket.2. Relative deflection of adjoining transverse web against transverse bulkhead.		See Sketch

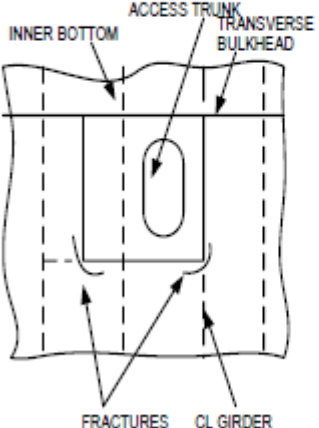
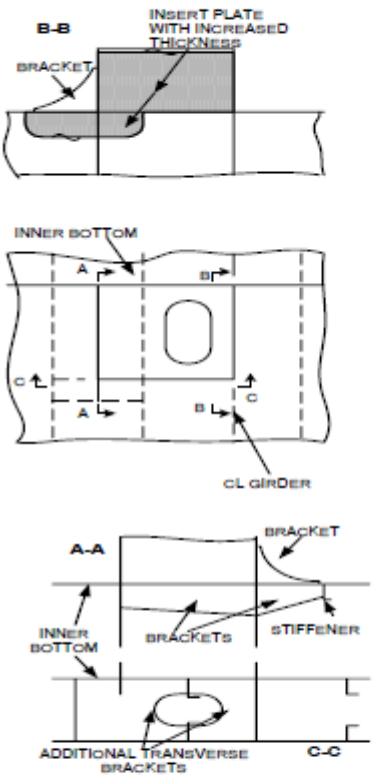
OIL Tankers		Guidelines for Surveys, Assessment and Repair of Hull Structure
Group 5	Cargo area	Example No.
	Transverse Bulkhead in cargo tank	4
Detail of damage	Fractured inner bottom plate at the connection to access trunk wall	
Sketch of damage

Sketch of repair

Factors which may have caused damage <ol style="list-style-type: none"> 1. Stress concentration at the connection of trunk wall to inner bottom plate. 2. Relative deformation between horizontal stringer fitted on transverse bulkhead and inner bottom plate. 3. Static and dynamic load of cargo liquid. 		Notes on repairs See Sketch.

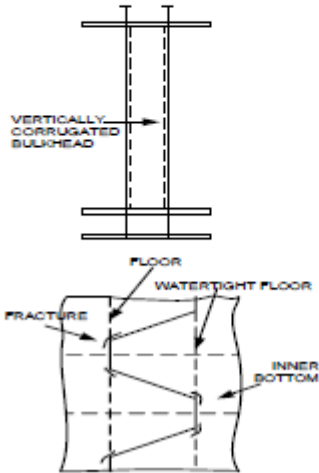
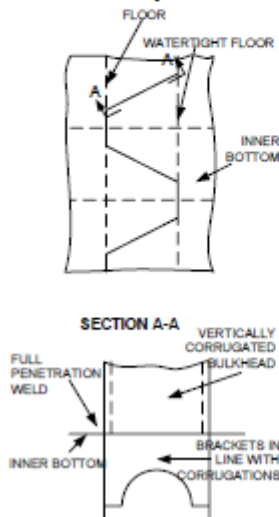
OIL Tankers		Guidelines for Surveys, Assessment and Repair of Hull Structure
Group 5	Cargo area	Example No.
	Transverse Bulkhead in cargo tank	6
Detail of damage	Vertically corrugated bulkhead without stool, connection to deck and inner bottom	
Sketch of damage		Sketch of repair

<p>The sketch shows a side view of a bulkhead structure. At the top, it is labeled 'VERTICALLY CORRUGATED BULKHEAD'. Below this, a horizontal line represents the 'FLOOR'. The bulkhead is shown connecting to the 'INNER BOTTOM'. A 'FRACTURE' is indicated at the connection point between the bulkhead and the floor. The floor is labeled 'WATERTIGHT FLOOR'.</p>

<p>The sketch shows the same bulkhead structure after repair. A 'FULL PENETRATION WELD' is shown at the connection point. The floor is labeled 'FLOOR' and 'WATERTIGHT FLOOR'. The bulkhead is labeled 'VERTICALLY CORRUGATED BULKHEAD'. The inner bottom is labeled 'INNER BOTTOM'. A section line 'SECTION A-A' is indicated. Brackets are shown 'IN LINE WITH CORRUGATIONS'.</p>

Factors which may have caused damage <ol style="list-style-type: none"> 1. Stress concentration due to unsupported corrugation web. 2. High through thickness stress, lamellar tearing. 3. Weld details and dimensions. 4. Misalignment between face of corrugation and floor underneath. 5. Cut-outs and scallops or air holes increasing the stress in the floor. 6. Insufficient through thickness properties of inner bottom plate. 		Notes on repairs See Sketch.

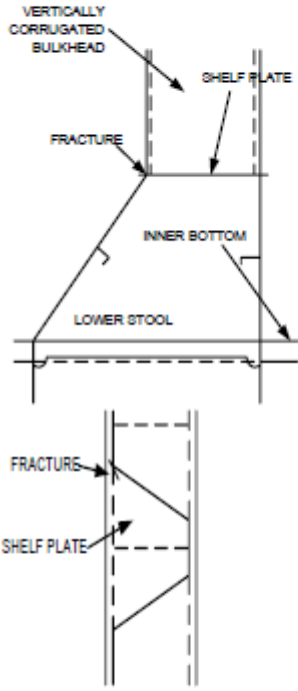
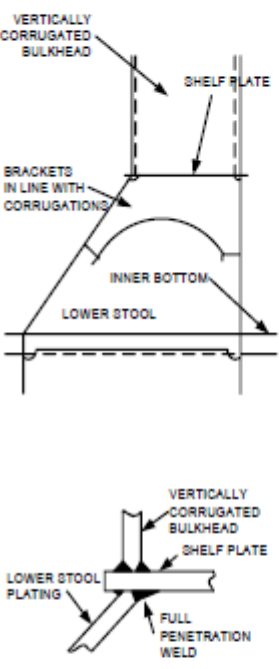
Factors which may have caused damage <ol style="list-style-type: none"> 1. Stress concentration due to unsupported corrugation web. 2. High through thickness stress, lamellar tearing. 3. Weld details and dimensions. 4. Misalignment. 5. Insufficient thickness of stool side plating in relation to corrugation flange thickness. 		Notes on repairs See Sketch.

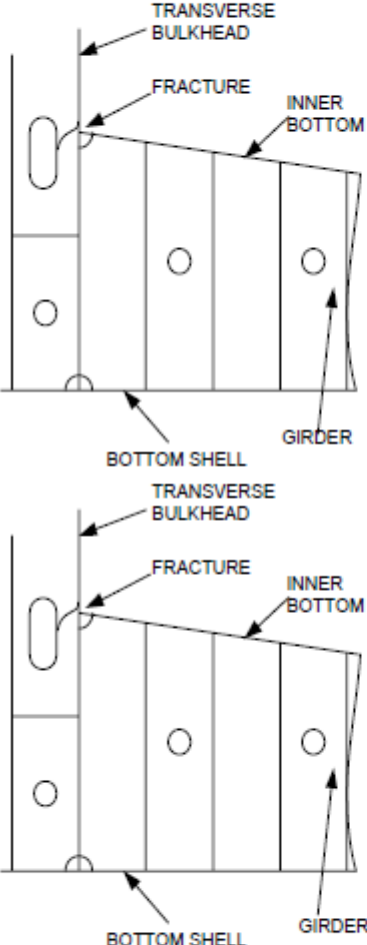
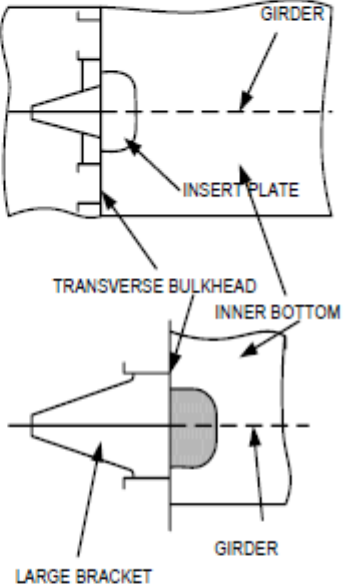
OIL Tankers		Guidelines for Surveys, Assessment and Repair of Hull Structure
Group 5	Cargo area	Example No.
	Transverse Bulkhead in cargo tank	9
Detail of damage	Fracture at connection of transverse bulkhead to knuckle inner bottom/girder	
Sketch of damage		Sketch of repair

Factors which may have caused damage 1. High stress concentration. 2. Discontinuity of structural members at knuckle joint.		Notes on repairs See Sketch.

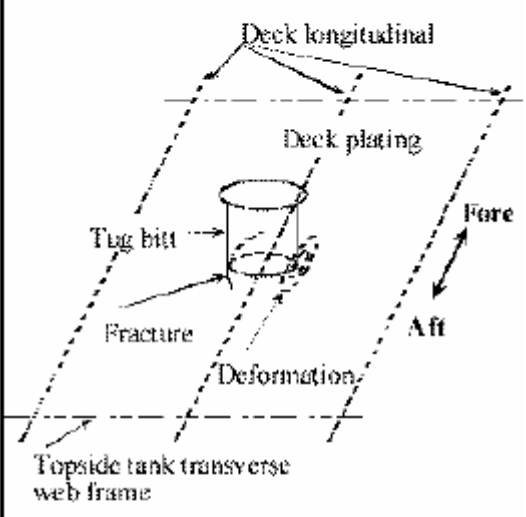
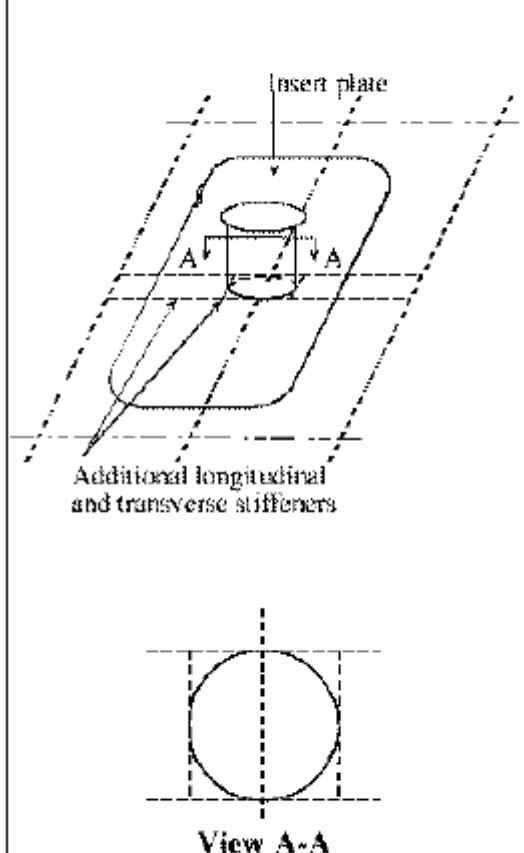
OIL Tankers		Guidelines for Surveys, Assessment and Repair of Hull Structure
Group 6	Deck Structure	Example No.
		1
Detail of damage		Deformed and fractured deck plating around tug bitt
Sketch of damage		Sketch of repair

Factors which may have caused damage 1. Insufficient strength		Notes on repairs 1. Fractured/deformed deck plating should be cropped and part renewed. 2. Reinforcement by stiffeners should be considered.

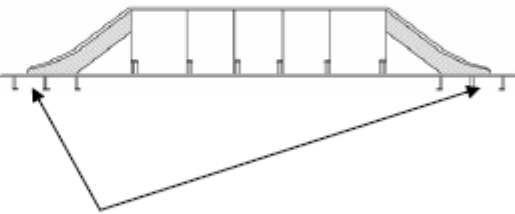
OIL Tankers		Guidelines for Surveys, Assessment and Repair of Hull Structure
Group 6	Deck Structure	Example No.
		2
Detail of damage		Fracture at ends of deck transverse
Sketch of damage		Sketch of repair

<p>Under deck transverse is to be described as mentioned in the following "Note on repairs".</p> <p>"Increase bracket length to end between under deck longitudinals and align end to under deck transverse."</p>
Factors which may have caused damage 1. High stress due to toes bracket ending at cut out for longitudinal.		Notes on repairs See Sketch. 1. Increase bracket length to end between underdeck longitudinals and align end to underdeck transverse. 2. Install fitted collar rather than lapped collar. 3. Insert deck plating if fracture extends into deck.

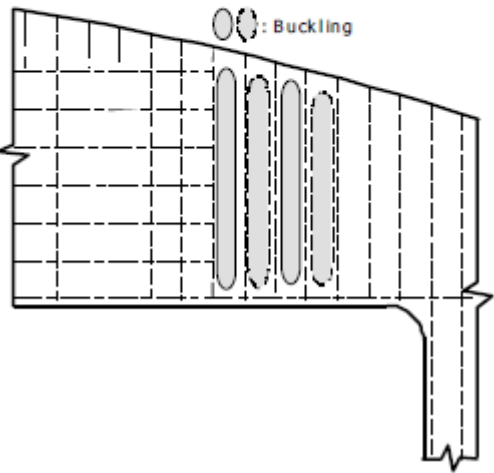
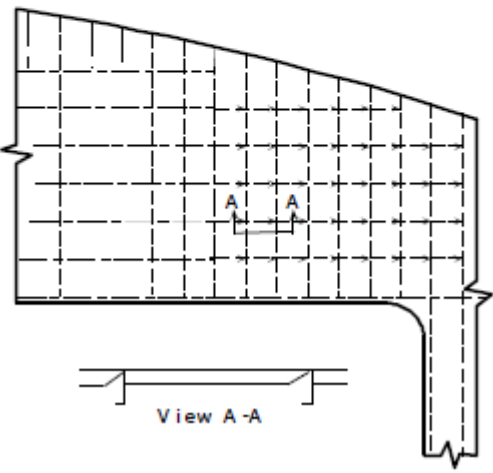
GENERAL CARGO SHIPS		Guidelines for Surveys, Assessment and Repair of Hull Structure
Part 1	Cargo hold region	Example No.
Area 1	Upper deck structure	1
Detail of damage	Buckling of deck plating of transverse framing system	
Sketch of damage

Sketch of repair

Notes on possible cause of damage 1. Excessive compressive stress due to slamming or bow flare effect. 2. Insufficient longitudinal stiffening of deck plating.		Notes on repairs 1. Buckled plating should be cropped and renewed. Longitudinal internal stiffeners should be provided. (Instead of longitudinal stiffeners, renewal by thicker deck plating can be accepted.) 2. Stress concentration may occur at the end of sniped stiffener resulting in fatigue fracture. For locations where high cyclic stress may occur, appropriate connection such as lug-connection should be considered.

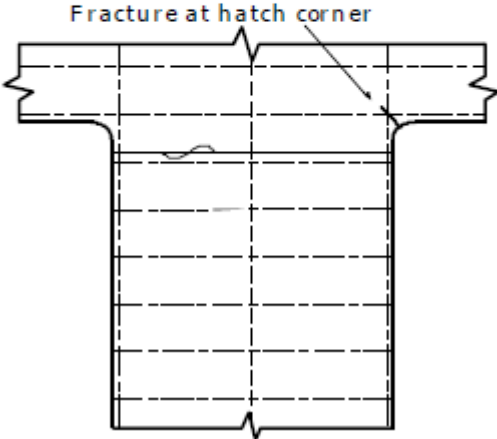
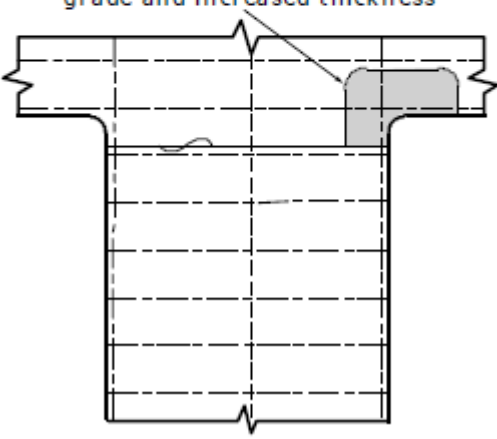
GENERAL CARGO SHIPS		Guidelines for Surveys, Assessment and Repair of Hull Structure
Part 1	Cargo hold region	Example No.
Area 1	Upper deck structure	2
Detail of damage	Fractures at main cargo hatch corner	
Sketch of damage

Sketch of repair Insert plate of enhanced steel grade and increased thickness

Notes on possible cause of damage <ol style="list-style-type: none"> 1. Stress concentration at hatch corners, i.e. radius of corner. 2. Welded attachment of shedder plate close to edge of hatch corner. 3. Wire rope groove. 		Notes on repairs <ol style="list-style-type: none"> 1. The corner plating in way of the fracture is to be cropped and renewed. If stress concentration is primary cause, insert plate should be of increased thickness, enhanced steel grade and/or improved geometry. Insert plate should be continued beyond the longitudinal and transverse extent of the hatch corner radius ellipse or parabola, and the butt welds to the adjacent deck plating should be located well clear of the butts in the hatch coaming. It is recommended that the edges of the insert plate and the butt welds connecting the insert plates to the surrounding deck plating be made smooth by grinding. In this respect caution should be taken to ensure that the micro grooves of the grinding are parallel to the plate edge. 2. If the cause of fracture is welded attachment of shedder plate, the deck connection should be left unwelded. 3. If the cause of the fracture is wire rope groove, replacement to the original design can be accepted.

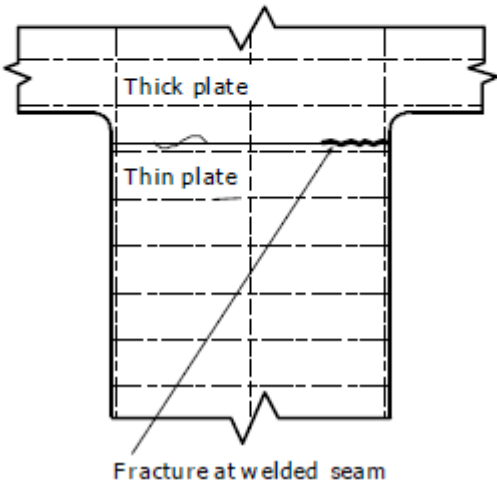
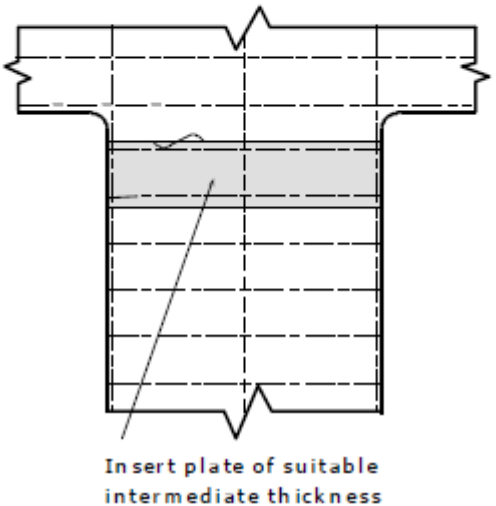
GENERAL CARGO SHIPS		Guidelines for Surveys, Assessment and Repair of Hull Structure
Part 1	Cargo hold region	Example No.
Area 1	Upper deck structure	3-a
Detail of damage	Fracture of welded seam between thick plate and thin plate at cross deck	
Sketch of damage		Sketch of repair

<p>Thick plate</p> <p>Thin plate</p> <p>Fracture at welded seam</p>

<p>Insert plate of suitable intermediate thickness</p>
Notes on possible cause of damage <ol style="list-style-type: none"> 1. Stress concentration created by abrupt change in deck plating thickness. 2. In-plane bending in cross deck strip due to torsional (longitudinal) movements of ship sides. 3. Welded seam not clear of tangent point of hatch corner. 		Notes on repairs <ol style="list-style-type: none"> 1. Insert plate of intermediate thickness is recommended. 2. Smooth transition between plates (beveling) should be considered.

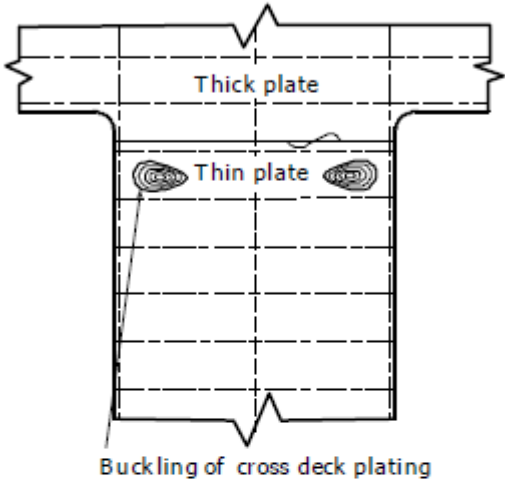
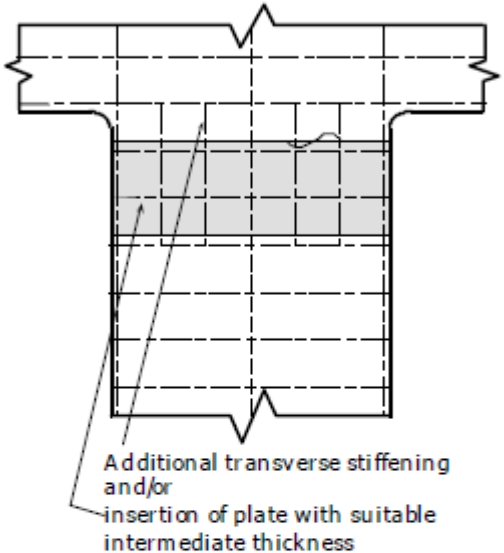
GENERAL CARGO SHIPS		Guidelines for Surveys, Assessment and Repair of Hull Structure
Part 1	Cargo hold region	Example No.
Area 1	Upper deck structure	3-b
Detail of damage	Plate buckling in thin plate near thick plate at cross deck	
Sketch of damage		Sketch of repair

Notes on possible cause of damage 1. In-plane bending of cross deck strip due to torsional (longitudinal) movement of ship sides, often in combination with 2. corrosion. Insufficient transverse stiffening.		Notes on repairs 1. Transverse stiffeners extending from hatch sides towards centerline at least 10% of breadth of hatch, and/or increased plate thickness in the same area.

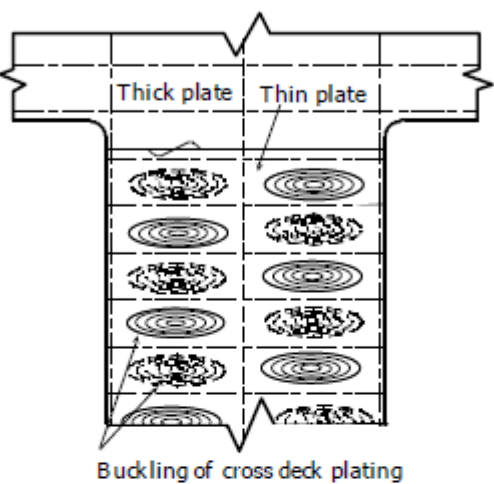
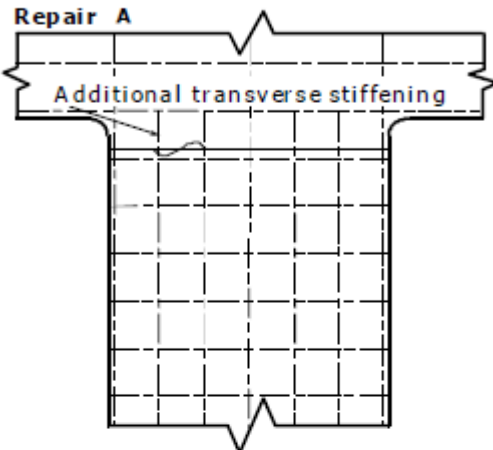
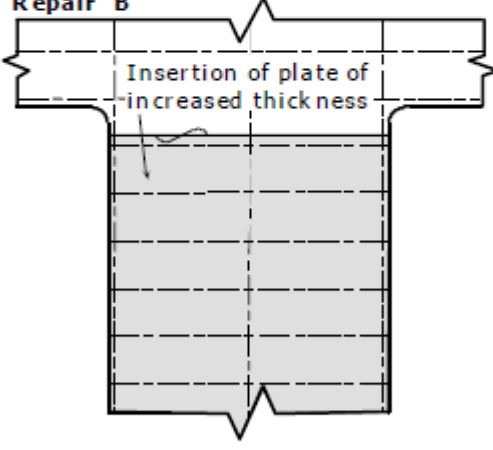
GENERAL CARGO SHIPS		Guidelines for Surveys, Assessment and Repair of Hull Structure
Part 1	Cargo hold region	Example No.
Area 1	Upper deck structure	3-c
Detail of damage	Overall buckling of cross deck plating	
Sketch of damage		Sketch of repair

<p>Repair A</p>

<p>Repair B</p>

Notes on possible cause of damage <ol style="list-style-type: none"> 1. Transverse compression of deck due to sea load. 2. Insufficient transverse stiffening. 		Notes on repairs <ol style="list-style-type: none"> 1. Repair A Plating of original thickness in combination with additional transverse stiffening. 2. Repair B Insertion of plating of increased thickness.

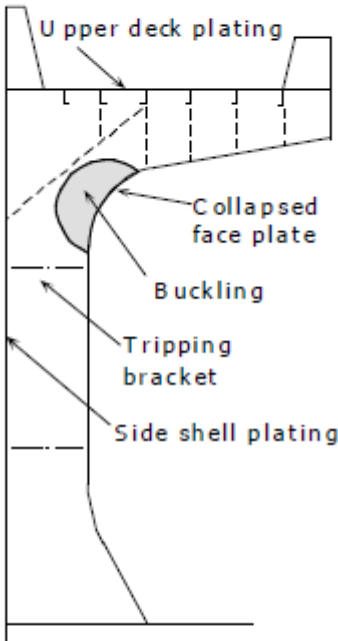
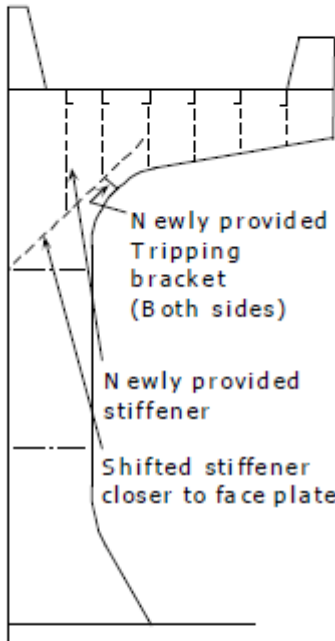
GENERAL CARGO SHIPS		Guidelines for Surveys, Assessment and Repair of Hull Structure
Part 1	Cargo hold region	Example No.
Area 1	Upper deck structure	4
Detail of damage	Buckling of web beam	
Sketch of damage

Sketch of repair

Notes on possible cause of damage 1. Overloading by green sea on deck or by excessive deck cargo. 2. Excessive corrosion. 3. Insufficient/improper web stiffening.		Notes on repairs 1. Buckled part is to be cropped and renewed. 2. If corrosion is not the cause, renewal by thicker plate (web and/or face) and/or reinforcement by stiffener and tripping bracket should be considered.

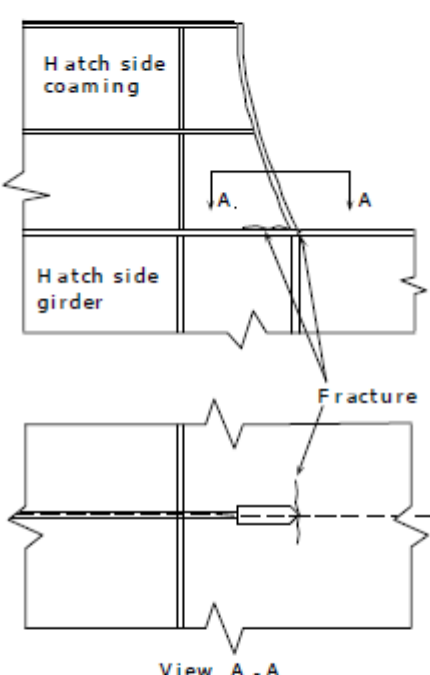
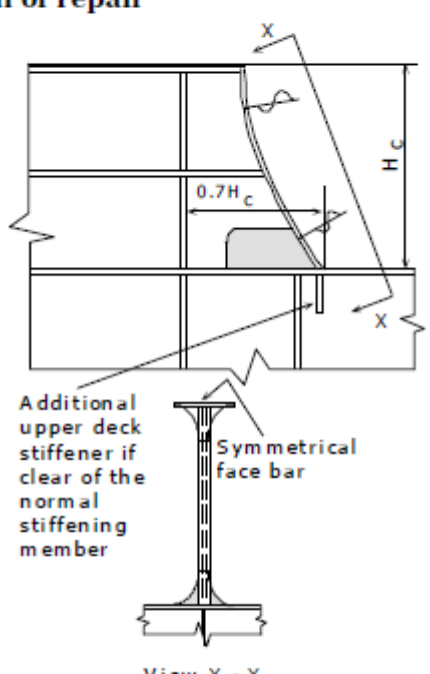
GENERAL CARGO SHIPS		Guidelines for Surveys, Assessment and Repair of Hull Structure
Part 1	Cargo hold region	Example No.
Area 1	Upper deck structure	5-a
Detail of damage	Fractures in the web or in the deck at the toes of the longitudinal hatch coaming termination bracket (discontinuous longitudinal hatch coaming)	
Sketch of damage		Sketch of repair

<p>Hatch side coaming</p> <p>Hatch side girder</p> <p>Fracture</p> <p>View A - A</p>

<p>Additional upper deck stiffener if clear of the normal stiffening member</p> <p>Symmetrical face bar</p> <p>View X - X</p>
Notes on possible cause of damage		Notes on repairs
<ol style="list-style-type: none"> 1. This damage is caused by stress concentrations attributed to the design of the bracket. 		<ol style="list-style-type: none"> 1. The design of the bracket can be altered as shown above, however, it is to be ensured that an additional under deck stiffener is provided at the toe of the termination bracket, where the toe is clear of the normal stiffening member. 2. Full penetration weld for a distance of $0.15 H_c$ from toe of side coaming termination bracket and for connection of athwartship gusset bracket to deck. 3. The fracture in deck plating to be veed-out and rewelded or deck plating cropped and part renewed as appropriate, using low hydrogen electrodes for welding.

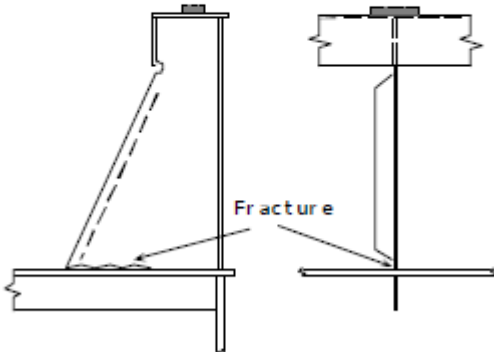
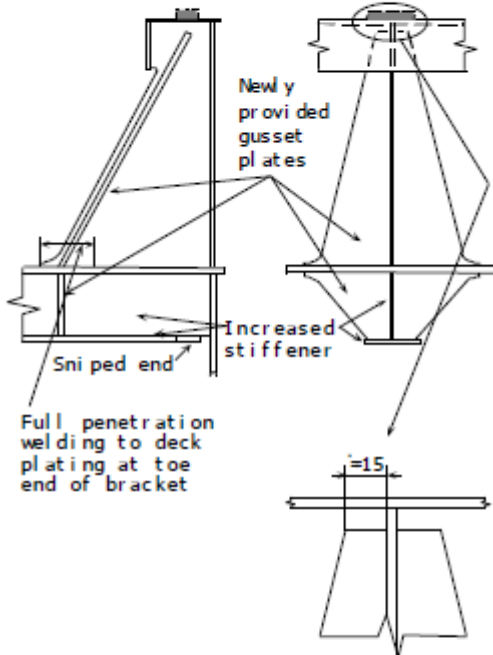
GENERAL CARGO SHIPS		Guidelines for Surveys, Assessment and Repair of Hull Structure
Part 1	Cargo hold region	Example No.
Area 1	Upper deck structure	6
Detail of damage	Fractures in web of transverse hatch coaming stay	
Sketch of damage		Sketch of repair

Notes on possible cause of damage 1. Insufficient consideration of the horizontal friction forces in way of the resting pads for hatch cover.		Notes on repairs 1. Modification of the design of the hatch coaming stay. 2. Full penetration welding between gusset plates and deck plating. 3. Strengthening and continuation of the structure below the deck. 4. Use pads with smaller coefficient of friction.

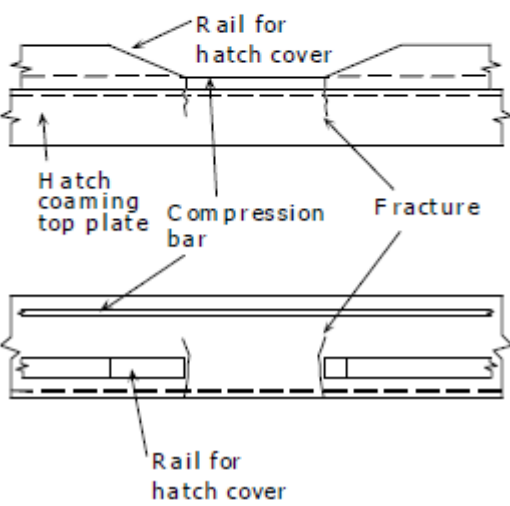
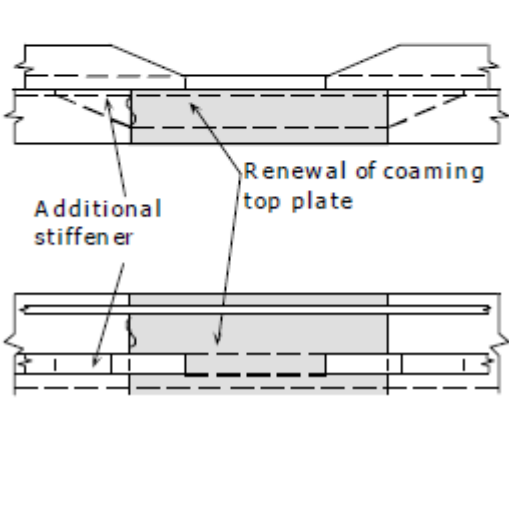
GENERAL CARGO SHIPS		Guidelines for Surveys, Assessment and Repair of Hull Structure
Part 1	Cargo hold region	Example No.
Area 1	Upper deck structure	7-a
Detail of damage	Fractures in hatch coaming top plate at the termination of rail for hatch cover	
Sketch of damage

Sketch of repair

Notes on possible cause of damage 1. Stress concentration at the termination of the rail for hatch cover.		Notes on repairs 1. Fractured plate is to be cropped and part renewed. 2. Thicker insert plate and/or reinforcement by additional stiffener under the top plate should be considered. Also refer to Example 7-b .

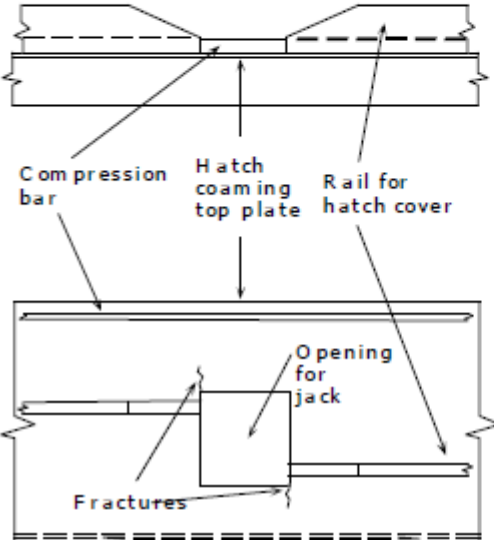
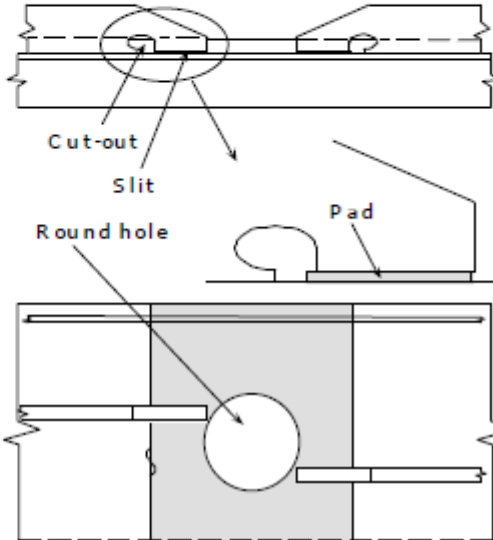
GENERAL CARGO SHIPS		Guidelines for Surveys, Assessment and Repair of Hull Structure
Part 1	Cargo hold region	Example No.
Area 1	Upper deck structure	7-b
Detail of damage	Fractures in hatch coaming top plate at the termination of rail for hatch cover	
Sketch of damage		Sketch of repair

Notes on possible cause of damage 1. Stress concentration at the termination of the rail for hatch cover.		Notes on repairs 1. Fractured plate is to be cropped and part renewed. 2. Thicker insert plate and/or reduction of stress concentration adopting large radius should be considered. Or cut-out in the rail and detachment of the welds as shown in the above drawing should be considered in order to reduce the stress of the corner of the opening.

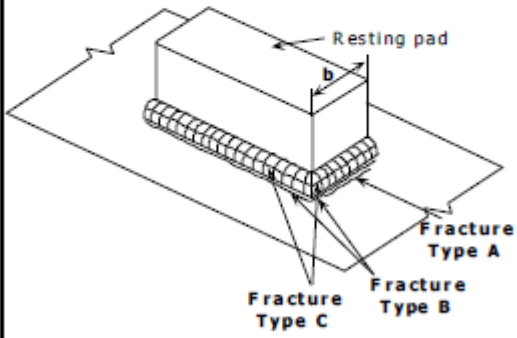
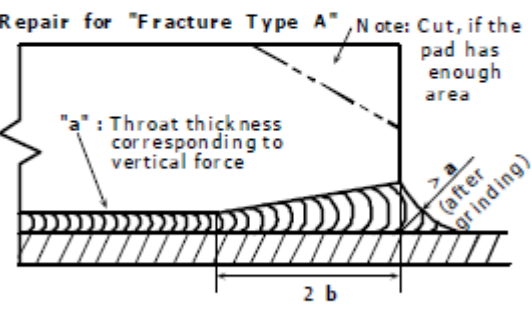
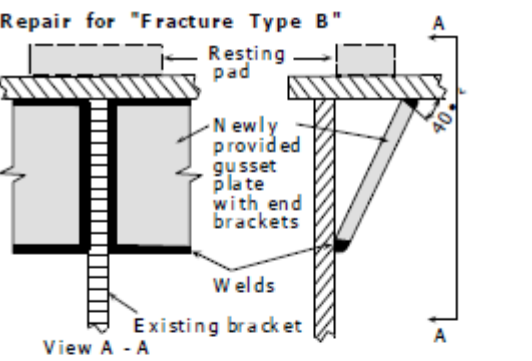
GENERAL CARGO SHIPS		Guidelines for Surveys, Assessment and Repair of Hull Structure
Part 1	Cargo hold region	Example No.
Area 1	Upper deck structure	8
Detail of damage	Fractures in hatch coaming top plate around resting pad	
Sketch of damage

<p>Fracture Type A: Starting in way of the undercut or HAZ of the transverse fillet weld and propagating in the top plating.</p> <p>Fracture Type B: Starting in way of the undercut or HAZ of the longitudinal fillet weld and propagating in the top plating.</p> <p>Fracture Type C: Starting and propagating in fillet weld</p>		Sketch of repair <p>Repair for "Fracture Type A" Note: Cut, if the pad has enough area</p>

<p>Repair for "Fracture Type B"</p>

<p>Notes on possible cause of damage</p> <ol style="list-style-type: none"> Fracture Type A: Inappropriate transition from the hatch coaming top plating to the resting pad in respect to longitudinal stresses. Fracture Type B: Insufficient support of the resting pad below the top plating. Fracture Type C: Insufficient throat thickness of the fillet weld in relation to the vertical forces. <p>Notes on repairs</p> <ol style="list-style-type: none"> Fracture Type A: Modification of the transverse fillet weld according to the sketch; in some cases smoothing of the transition by grinding is acceptable. Fracture Type B: Strengthening of the structures below the top plating according to the sketch. Fracture Type C: Increasing the throat thickness corresponding to the acting vertical forces.

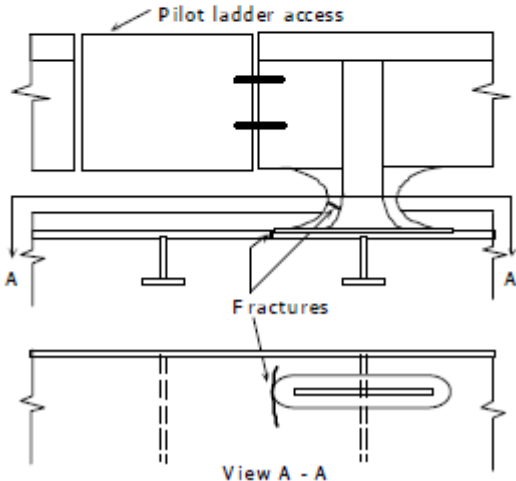
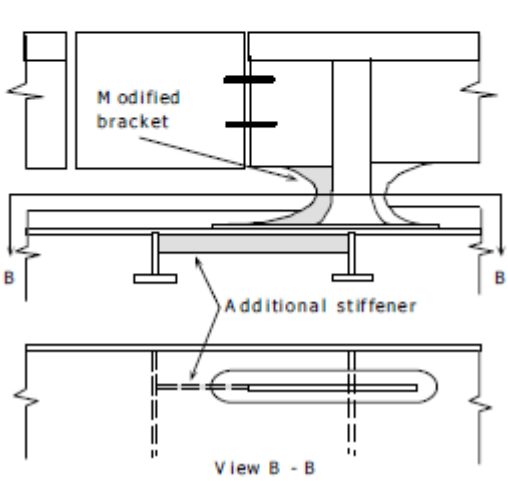
GENERAL CARGO SHIPS		Guidelines for Surveys, Assessment and Repair of Hull Structure
Part 1	Cargo hold region	Example No.
Area 1	Upper deck structure	9
Detail of damage	Fracture in deck plating at the pilot ladder access of bulwarks	
Sketch of damage

Sketch of repair

Notes on possible cause of damage 1. Stress concentration at the termination of bulwarks.		Notes on repairs 1. Fractured deck plating should be cropped and part renewed. 2. Reduction of stress concentration should be considered. In the above figure gusset plate was replaced with soft type for the fracture in gusset plate and pad plate was increased. Additional stiffeners were provided for the fracture in deck plating.

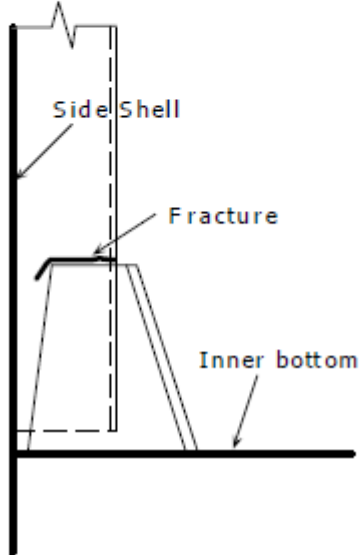
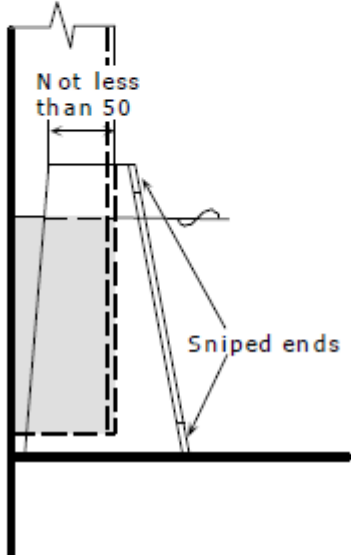
GENERAL CARGO SHIPS		Guidelines for Surveys, Assessment and Repair of Hull Structure
Part 1	Cargo hold region	Example No.
Area 2	Side structure	1
Detail of damage	Fracture in side shell frame at lower bracket	
Sketch of damage

Sketch of repair

Notes on possible cause of damage 1. This type of damage is caused due to stress concentration.		Notes on repairs 1. For small fractures, e. g. hairline fractures, the fracture can be veed-out, welded up, ground, examined by NDT for fractures, and rewelded. 2. For larger/significant fractures consideration is to be given to cropping and partly renewing/ renewing the frame brackets. If renewing the brackets, end of frames can be sniped to soften them. 3. If felt prudent, soft toes are to be incorporated at the boundaries of the bracket to the inner bottom plating.
